A Comparison of Active and Passive Magnetic Ranging Techniques in a Relief Well Application

Clinton Moss
Halliburton – Sperry Drilling

**SPE Wellbore Positioning Technical
Section Meeting #36**

Oct 11th, 2012

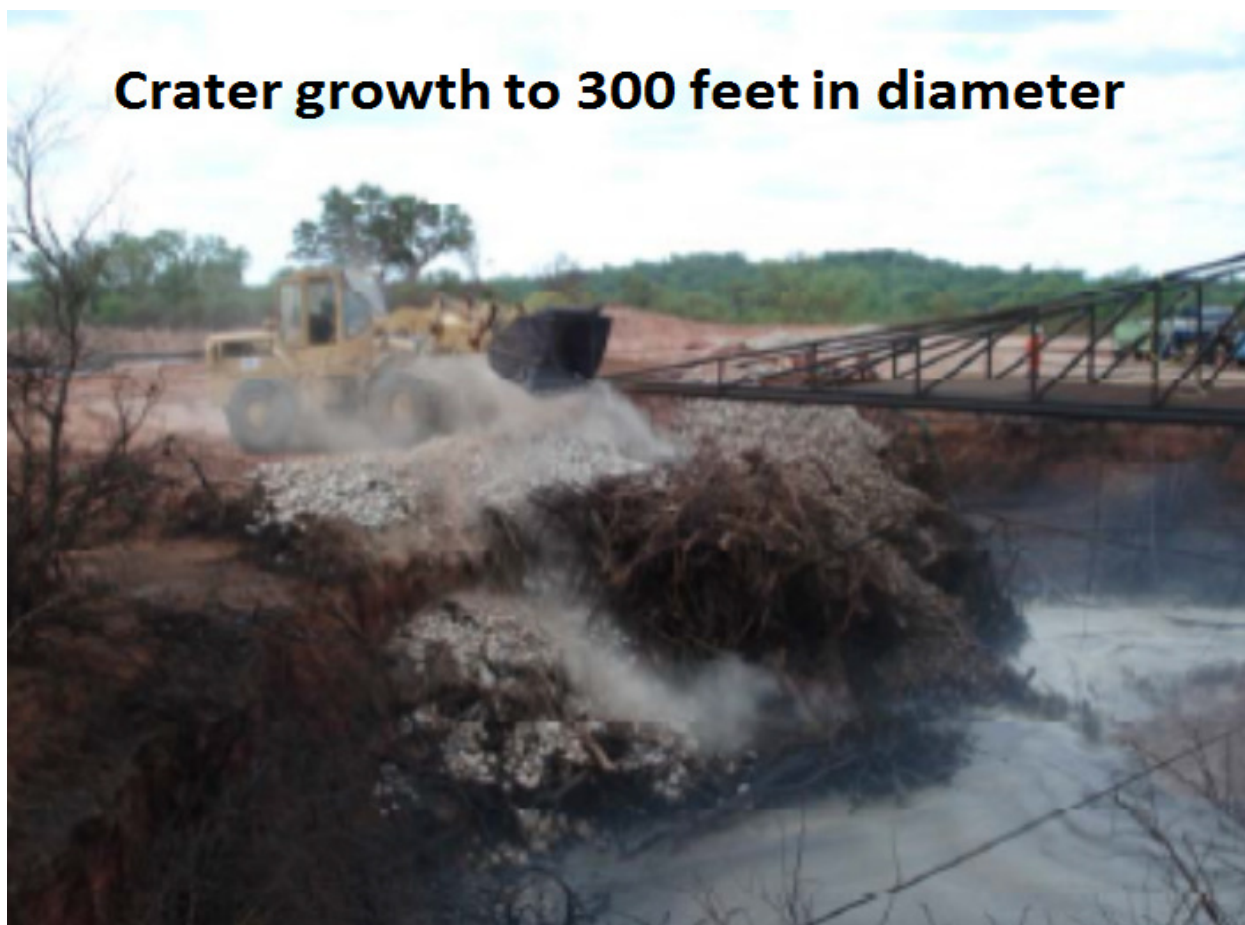
MdT-14 Site Assessment

- MdT-14 was drilled in 1975, abandoned in 1978 and observed to be out of control in 2006.
- A crater 300 feet wide formed around the wellhead.
- The well produced water at high volume. CO₂ from the well endangered crew and killed livestock in the area.
- After an unsuccessful surface intervention attempt in 2007, a relief well was planned.

Crater growth to 300 feet in diameter

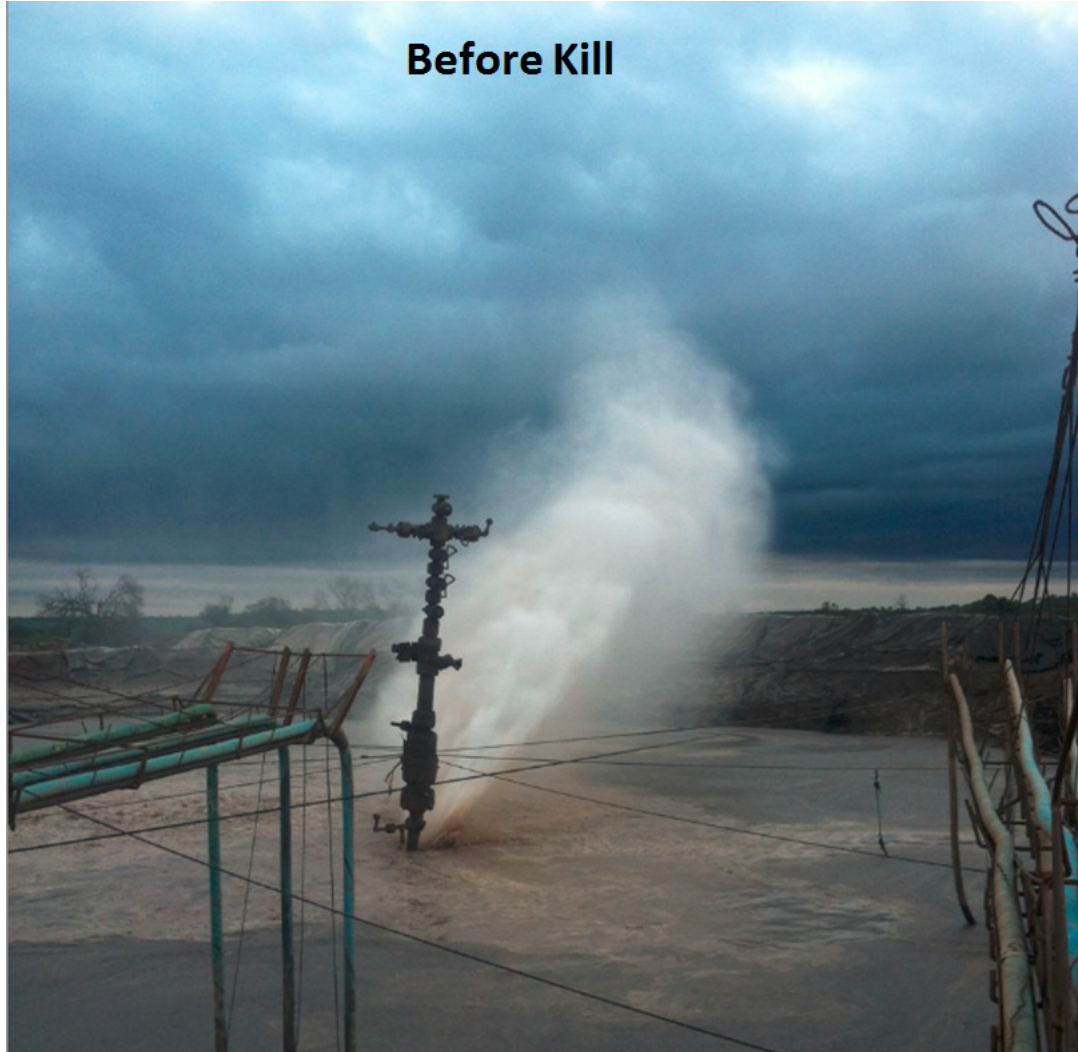
Before Kill

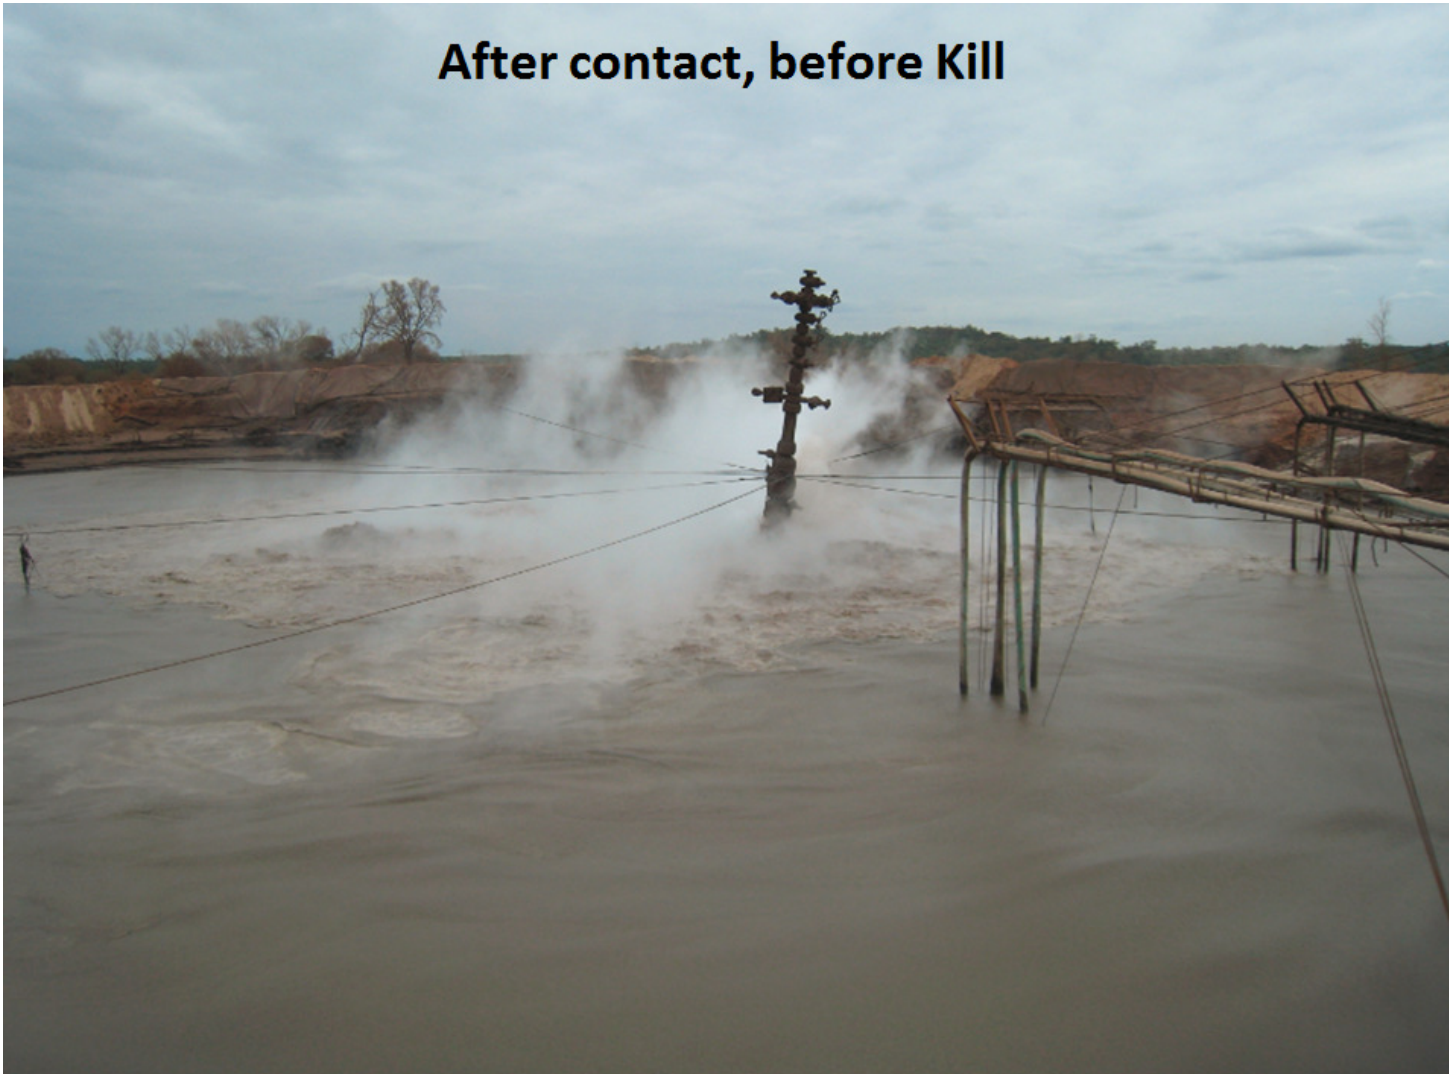
After contact, before Kill

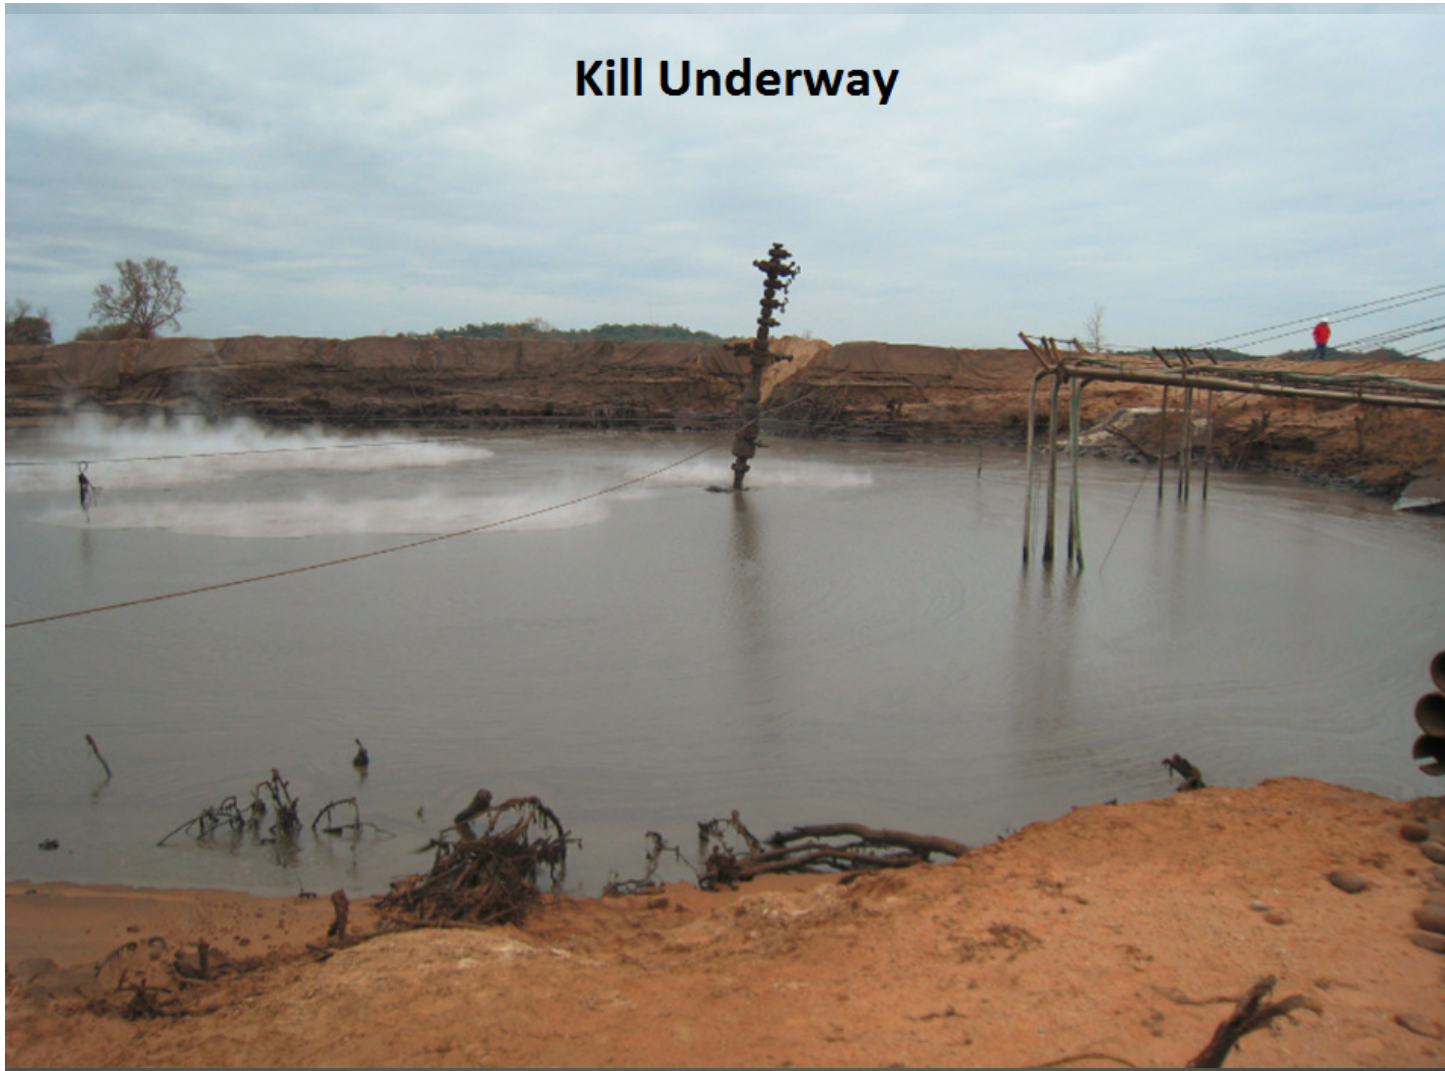
Kill Underway

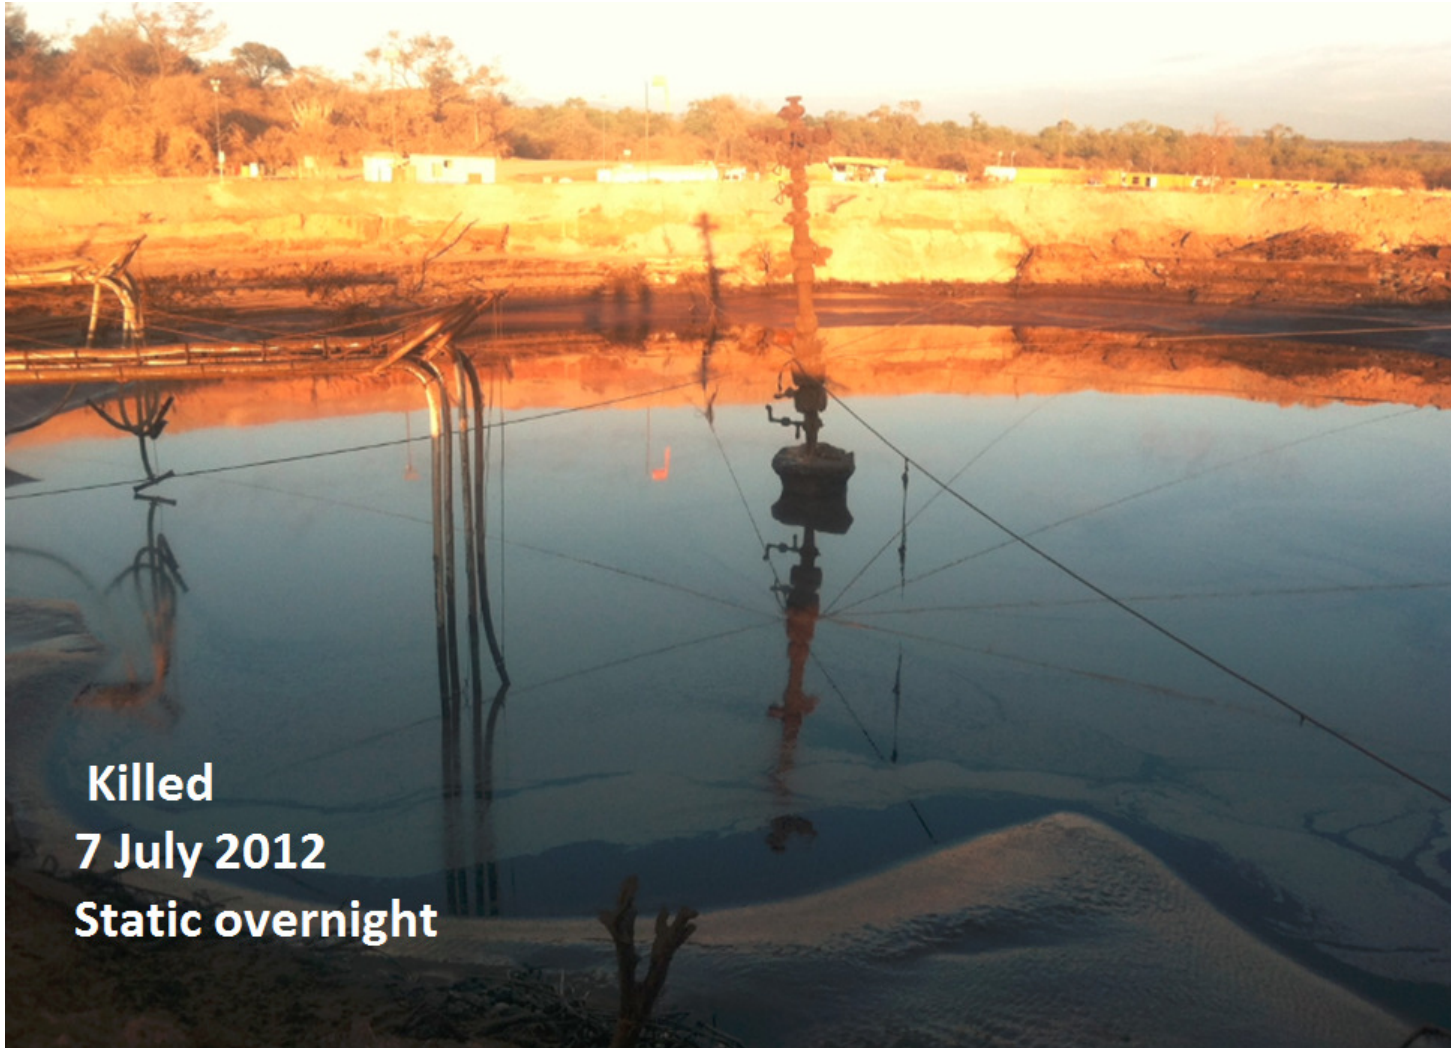
**Killed
7 July 2012
Static overnight**

- The target well was intersected on the first attempt without the need for any sidetracks. **Full hydraulic communication was established.**
- On July 6th 2012, the target well was dynamically killed two weeks ahead of schedule.
